MONTANA DEPARTMENT OF TRANSPORTATION STREAM MITIGATION MONITORING REPORT

*Mill Creek
Ravalli County, Montana*

*Project Constructed: 2011
Monitoring Report #4: December, 2016*

STREAM MITIGATION MONITORING REPORT #4

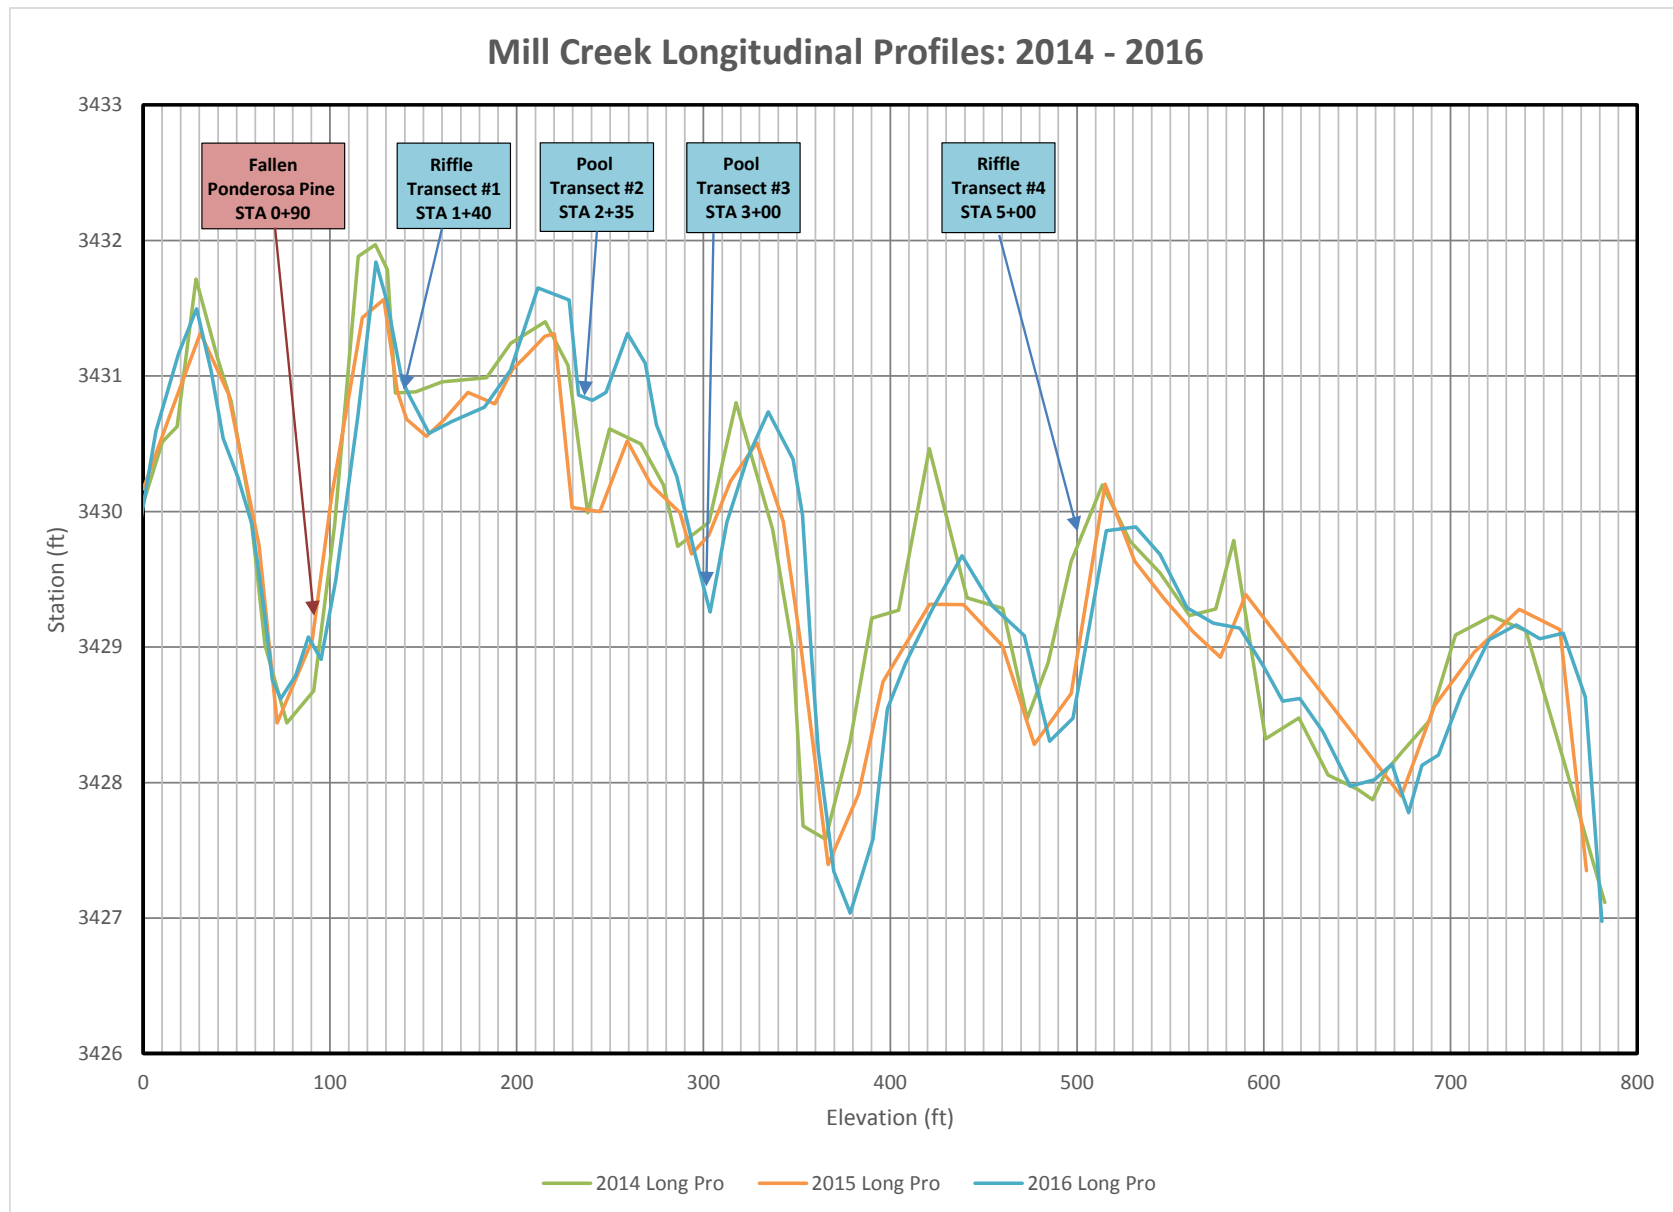
Figure 2. Thalweg longitudinal profile along Mill Creek, 2014 – 2016.

A longitudinal profile of the stream bed along the thalweg was repeated in 2015 and again in 2016 to document bedform complexity and aquatic habitat conditions (Appendix B). The profile exhibits a diversity of channel depths, with both shallow and deep pools within the project reach. The most visible difference in the profile occurs between station 2+00 and 3+00, where a gravel deposit has elevated the stream bed downstream of the large, newly fallen ponderosa pine tree. Otherwise, the channel bed has maintained a relatively consistent slope over the past four years.

As indicated in previous monitoring reports, this reach of Mill Creek is actively transporting an abundance of gravel and cobble originating from the upper watershed. The project reach, as well as a lengthy segment of channel observed upstream, exhibits many gravel and cobble point bars and islands, which are indicative of a watershed with a large supply of bedload. Observations of the stream banks along the project reach indicates gravel and cobble material is also generated during lateral bank migrations. As a result of the high bedload composition of Mill Creek, the stream bed forms vary from year to year, with scour and depositional processes influenced by evolving meander patterns and woody debris complexes. Creeks transporting a large supply of cobble and gravel tend to laterally migrate more rapidly as bars develop and bank woody debris is recruited to the channel. The Mill Creek monitoring reach includes several large trees and woody debris complexes, which generate bedform complexity and aquatic habitat variability. As a result of these factors, channel adjustments are likely to continue occurring within the monitoring reach. Adjustments to the channel noted during the monitoring of this project site include the large point bar immediately upstream of the project reach advancing further north each year, deposition of gravels along the stream bed downstream of the newly fallen ponderosa tree, and shifting mid-channel bars observed between STA 2+75 and 3+50. These adjustments and the subsequent erosion/deposition observed do not necessarily equate to channel instability, as these are natural processes that occur within meandering stream channels.

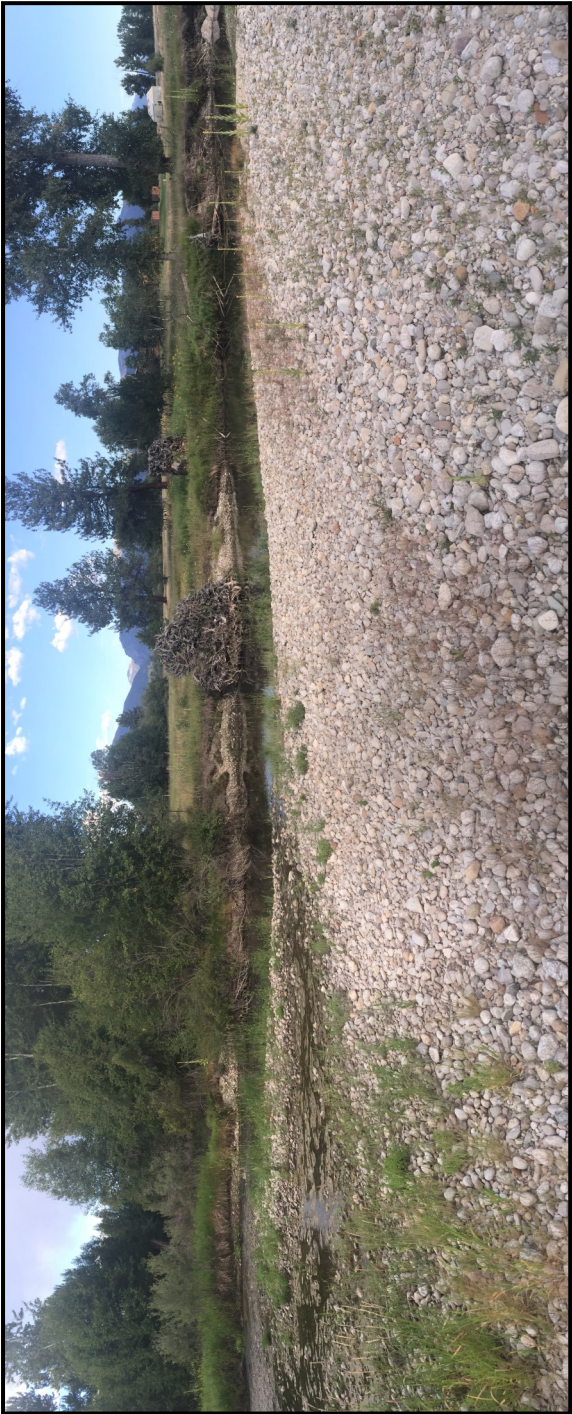
Erosion of the north bank (EBL1-2) immediately upstream of the project reach has advanced northward each year since the inaugural monitoring event in 2013. This bank occurs upstream of the relocated channel segment, and has been continuously observed due to its influence on the reach immediately downstream. This bank migrated an additional 2-3 feet during the past year, causing a large ponderosa pine tree to fall into the river. While recruitment of woody debris is considered a positive effect on the channel due to its ability to help develop pool habitats, this tree is large enough to trap other woody material and result in more accelerated channel migration in its vicinity. Channel migration near this downed tree should be monitored to document whether unintended erosion occurs as a result of its presence.

Additional Photo 1
Description: Eroding Bank EBL1 - 2016 (panoramic)

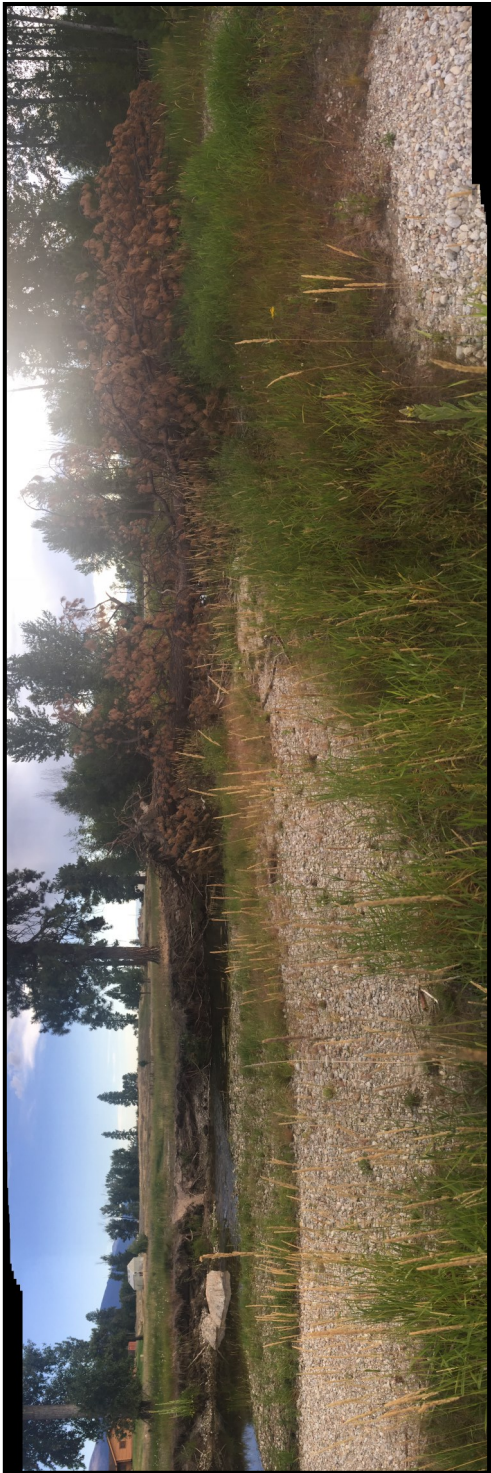
Additional Photo 2
Description: Eroding Bank EBL2 - 2016 (panoramic)

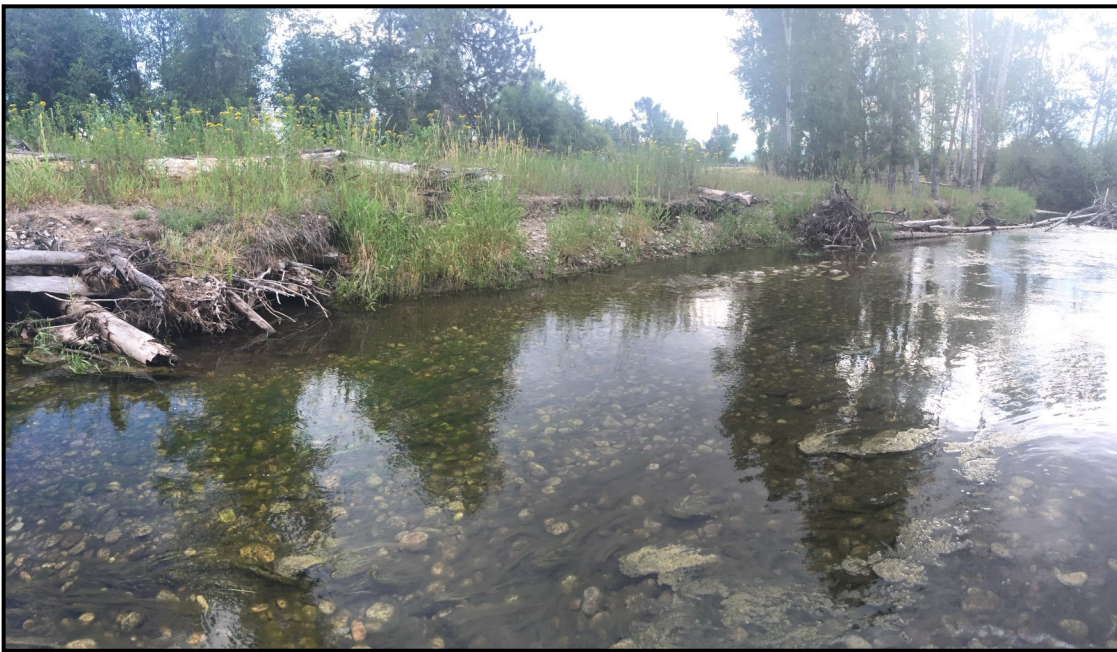
Additional Photo 3

Erosion at EBL3 is occurring at the head of the former channel alignment (now backfilled with gravel, cobble, and soil), and extends downstream approximately 90 feet beyond the root ball of a fallen tree. In 2014, erosion was noted along the toe of the

Description: Upper section of Eroding Streambank EBL3 in 2016

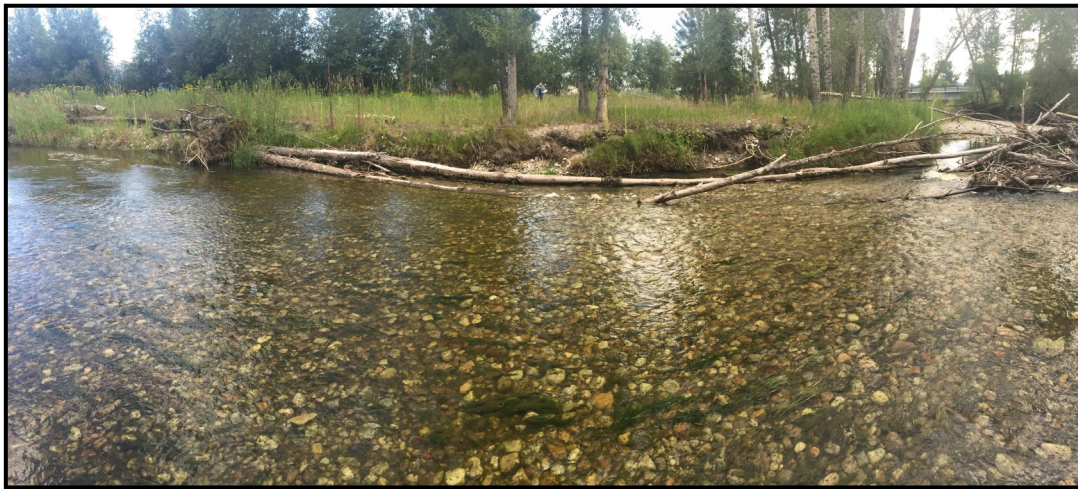
Additional Photo 4

Description: Lower section of Eroding Streambank L3 in 2016 (panoramic)

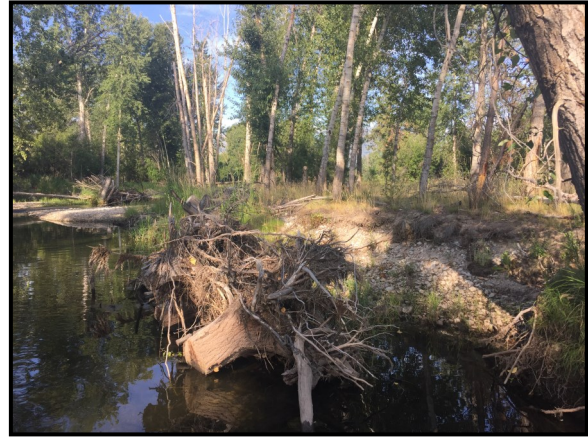
Lateral erosion at bank EBL4 appears to have continued since 2015, as evidenced by the adjacent root balls detaching from the bank (see Additional Photo 5 in Appendix C). The bank has retreated approximately 4-5 feet since 2013, although the eroding bank length of 64 feet has not increased. Bank instability at this location was potentially caused by removal of the trees for use in log revetment construction, or from natural channel adjustments following construction. The dominant vegetation along the bank includes reed canary grass and smooth brome, the former of which offers dense roots capable of withstanding erosion more effectively than most species. Erosion severity along this bank is considered low to moderate and does not jeopardize any infrastructure elements or the newly installed bridge downstream. As a result of the erosion occurring likely as a result of natural channel adjustments, no corrective actions are warranted at this location.

Description: Eroding streambank EBL4 in 2016.

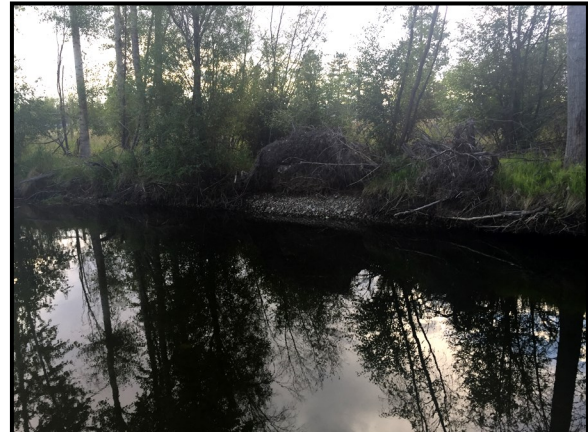
Additional Photo 6

Description: Eroding streambank EBR1 in 2016.

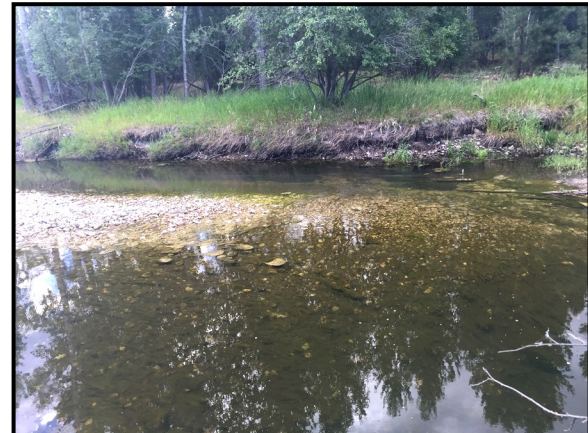
Erosion at EBR2 was noted along 65 feet of the channel across from the head of the deactivated stream channel. Erosion at this location is due to channel adjustments and scour along the outside of a meander. No additional erosion was noted over the past two years along this bank (see Additional Photo 7 in Appendix C). The vegetation community is dominated by reed canary grass with a speckled alder and bog birch overstory. Each of these species are generally capable of withstanding erosive forces. These factors contribute to an overall low erosion severity rating and no corrective actions are warranted along this bank.

Description: Eroding streambank EBR2 in 2016.

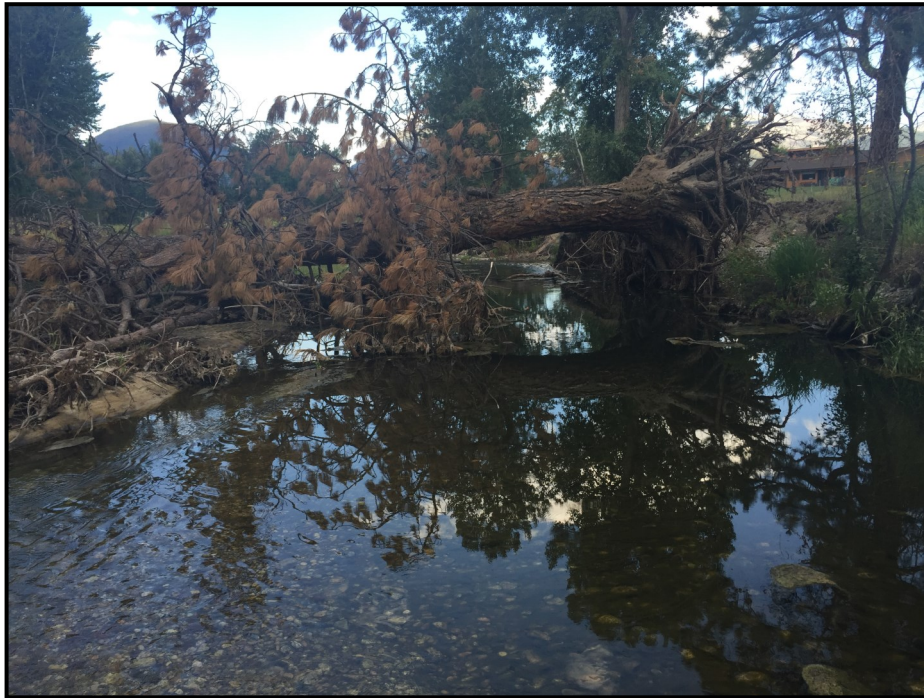
Additional Photo 8—2016

Description: Ponderosa pine in channel near downstream end of EBR2
